Identifications and investigations of hazardous road locations on Dhaka-Aricha Highway

ABSTRACT: The Dhaka-Aricha highway plays a vital role in interregional road transport in Bangladesh but unfortunately, this corridor is the most hazardous corridor in terms of accidents and fatalities per kilometer. According to police reported accident record, every year almost 180 accidents and 120 fatalities occurred on this 75 km segment of the national highway. Investigation reveals that significant numbers of accidents are highly concentrated at few locations. Such locations with abnormally high concentration of road accidents are identified as 'Hazardous Road Locations' (HRL). Analysis shows that, almost 25 percent accidents took place in the 10 locations on road comprising only 3 percent of the total roadway segment. An in-depth study has been conducted to identify the major hazardous locations of that highway corridor and to evaluate the causative factors of accidents on those locations through data analysis, using GIS technology, on site field observation and focus group discussion. This paper summarized the findings of that brief study. At the very outset of the paper, the scale and m

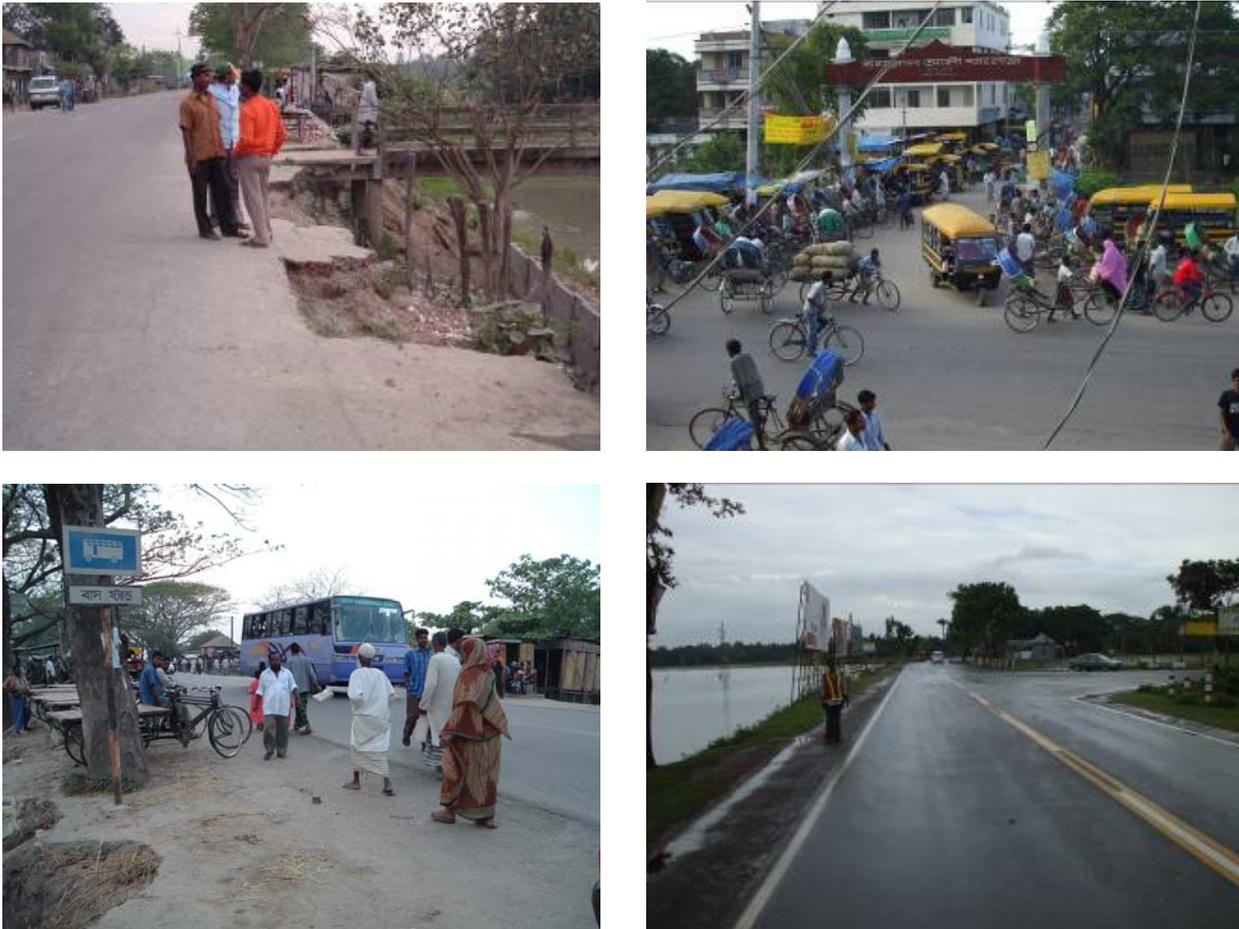
Figure 2: Glimpses of Road and Road Environmental Deficiencies

- Adverse roadway elements contributing to highway accidents were substandard road way alignment or geometry, lack of shoulders and shoulder defects, absent or inappropriate pedestrian facilities, narrow and defective lanes and bridges/bridge approaches, uncontrolled as well as staggered access roads in many of the locations.

- In the entire study section, unmarked pavement condition is considered to be good in many of the locations. Smooth road surface and very few potholes or undulations were found. However there is no usable shoulders or edge and pavement centre and edge line markings many of the sections of the selected road.

- In general, road signs, markings and other regulatory devices were found to be very insignificant to regulate and control traffic.
- Poor sight distances and visibility, unmarked and inappropriate design of intersections like Paturia intersection, serious delineation deficiencies along the route are poses serious safety threat in many sections of the road.

- Most of the temporary shops and stalls are built just besides the road which obstructs the visibility when traffic from access roads merges into the main traffic stream.

- Overall situation is worsen by illegally use of the roadsides or encroachment of the road sides for trading, shopping, marketing, piling of wooden logs and other goods, parking and loading /unloading activities which force the pedestrians use the high-speed road carriage way.
- Very complex and high roadside frictions with varied local activates and functions due to high concentration of retail/trading centers particularly at the Bazaar day.
- There is very few dedicated side walk or cross walk facilities for pedestrians except savar and absence of regulatory/warning signs or signals which are highly required particularly for the bazaar and built-up areas. In absence of footways pedestrians are forced to use the high-speed carriage ways and there by face conflicts with motor vehicles.

- Physical separation of pedestrians from motorized traffic particularly in the sites in urban or bazaar areas where the concentration of pedestrian is very high.

- Treatments of road shoulders; wide and strong shoulders are seen as particularly important to cater for pedestrian, cyclist, rickshaw and animal drawn traffic

- Adequate access control through proper geometric design modifications of access roads and placement of give way and stop signs and markings.
- Installation of proper traffic sign in proper place and ensuring of the maintenance of that sign.

- Treatment and re-location of physical obstructions e.g. poles, trees, shops and other objects.
- Provision of rural bus bays to provide of road operation for bus to pickup/drop passengers.

- Relocation of road side bazaar and hut in a proper place to avoid road and road side conflict with the local activities.

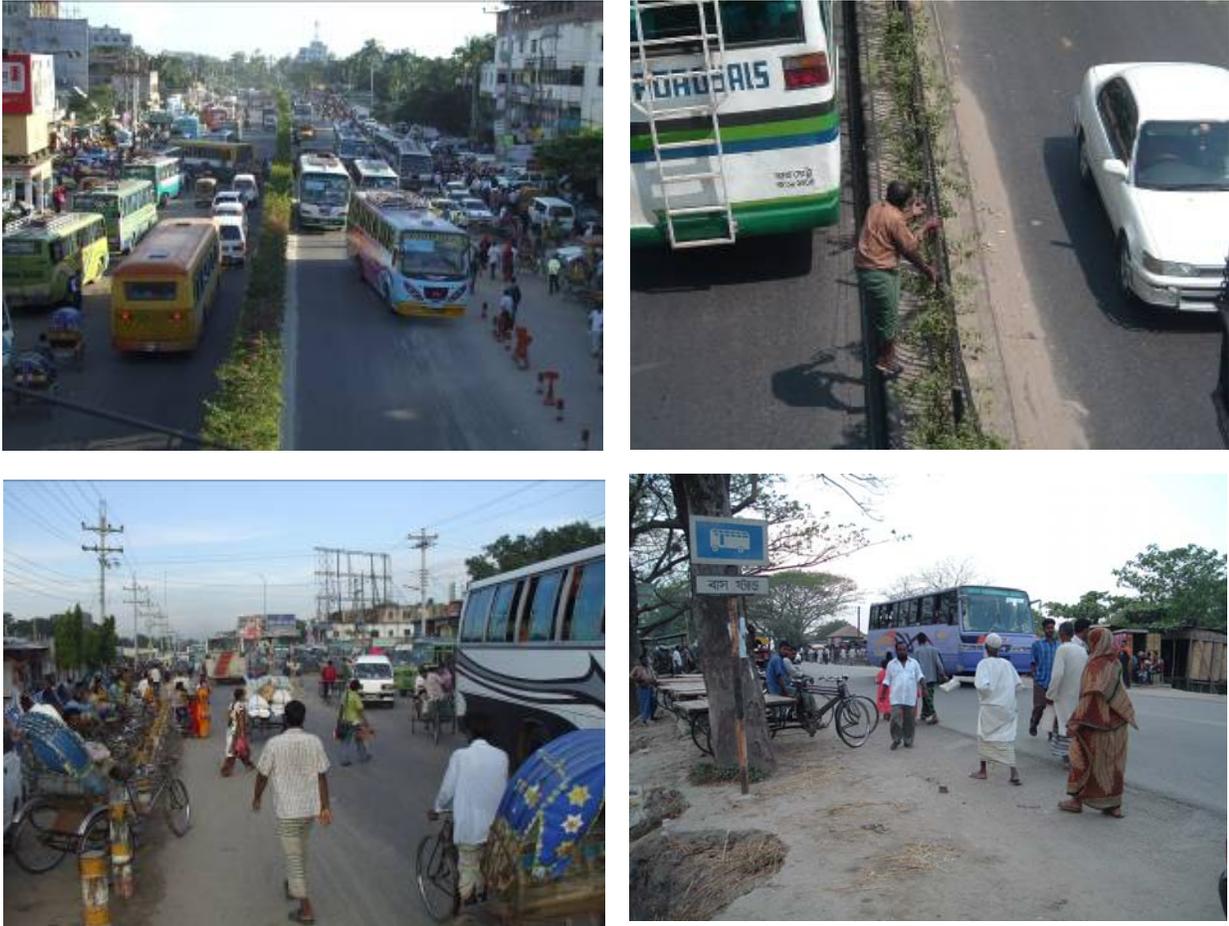
Figure 3:

- High speed, high occupancy through traffic mostly commercial vehicles very often have conflicts with local low speed operated minibuses, tempos and other non-standard vehicles, particularly NMVs from access roads. Traffic from unmarked access roads also creates hazards.

- Frequently access of vehicle from the side road also creates create conflicts and operational hazards of the site. Most of the driver does not follow the traffic rules, sign and markings and there is a lack of traffic police on the sites also.

- Reckless overtaking, overloading and braking/stopping on road and road sides poses a great operational as well as safety hazards of all the section.
- Absence of edge line and centerline markings or other delineation devices lead drivers into unsafe operations and their path selection.

Glimpses of Traffic Operational and Behavioral Hazards

- Self-enforcing physical measures are necessary to encourage and or force drivers to slow down and controlling of over speeding. Some sort of speed calming devices (rumble strips or jiggle bars) may be placed to control over-speeding vehicles and driver aggressiveness.

- Raised reflective pavement and edge markers, guide posts, chevrons are of critical importance to the safe and efficient operation of the road system and are vital in enabling drivers to locate the vehicle on the roadway and to make path selection and control decisions

- A local community based road safety program could be developed for raising safety awareness among the local people for their safety conscious behaviour and actions.
- Strict regulatory and law enforcement measures are seen important to reduce roadside frictions and hazards.
- Additional police enforcement is needed particularly at day of Bazaar in some locations.
- Training of police personnel is vitally important for proper enforcing of traffic laws and regulation and proper recording and reporting of accident.
- Basic road safety education should be introduced in the primary curriculum importantly in the roadside school.
